Mochovce 3 nuclear project: current problems

Recently, new photo evidence has emerged by another manager (whistleblower 3) working until spring 2019 for the Mochovce 3 nuclear project.

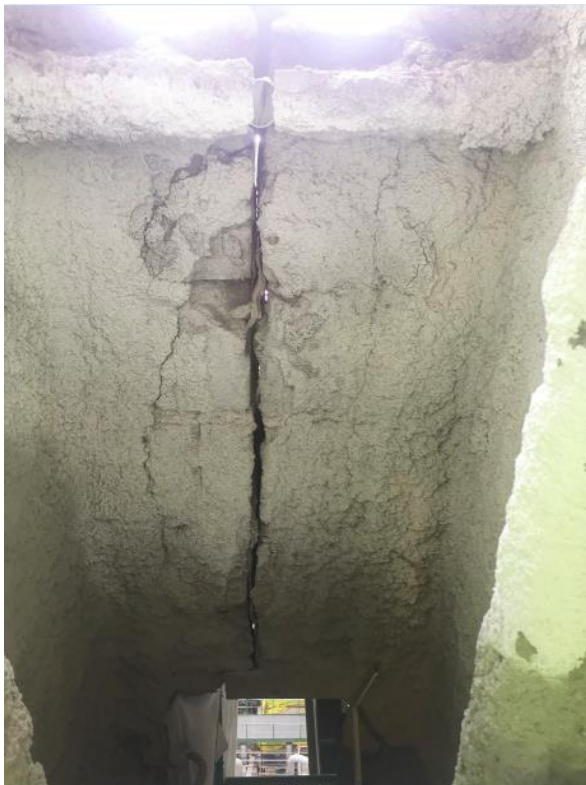
6.12.2018 Stairwell next to Turbine hall

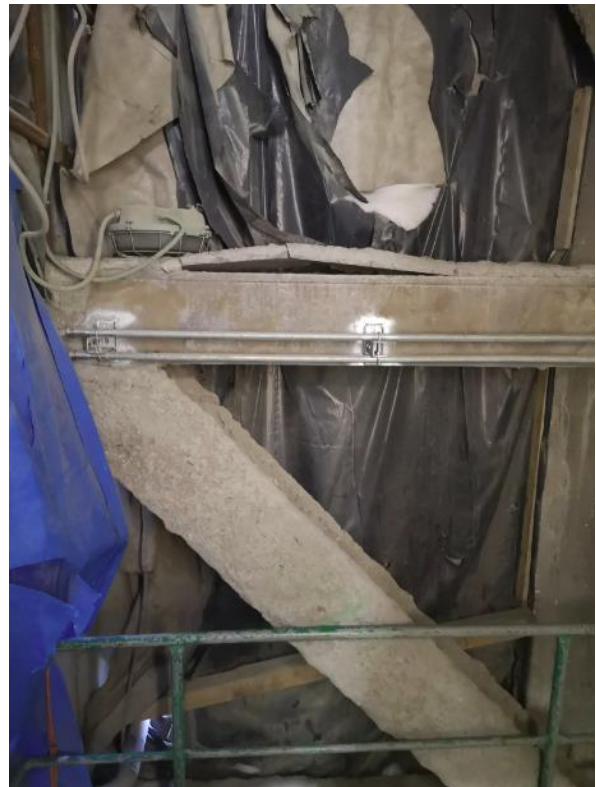
10.1.2019 bent Beam next to Turbine hall

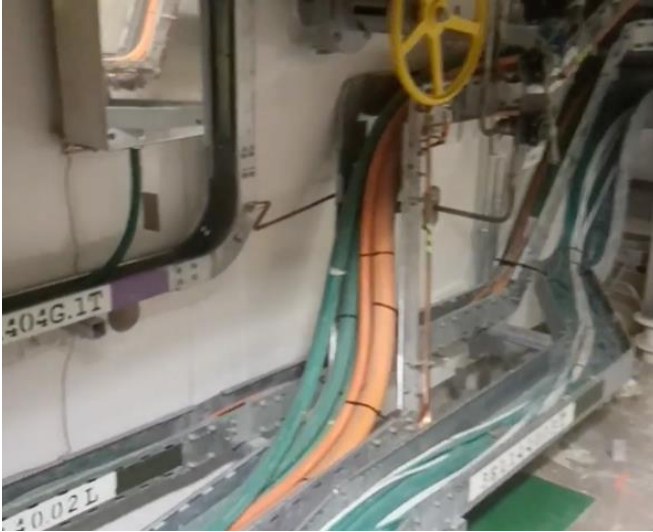
(date of video: 1.12.2018)

Above is a frame taken from one of the videos. Beside the unordered laying of the cables, it is clear that the green cable is too short. Similar cases are very common in EMO34.

But the most serious thing is that no non-compliance report has been raised for the problem of short and poorly laid cables. Not even a report to accept that they are good as they are. This is contrary to the project rules approved by UJD – UJD never raised this issue.

The disastrous laying of the power cables without considering their heating / cooling will create many problems in the future for the plant.

This is much more serious than it seems. **To guarantee a lifetime of 40 years, the cables should have extra length in each end. This with the aim of being able to guarantee the reconstruction of the terminations in case of failure or aging.** The requirement was not respected at all. No one of the requirement introduced in order to ensure the 40 years of operation (longer than EMO12) was respected.

From the technical point of view, the cables are installed so badly that they should be completely relayed.

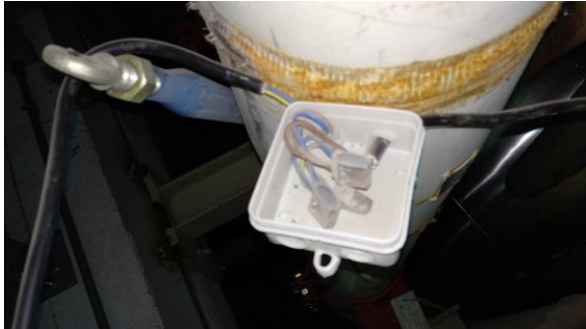
14.3.2018 open connection with dirt

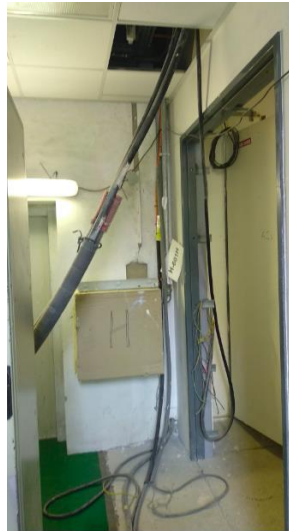
18.5.2018 Staircase

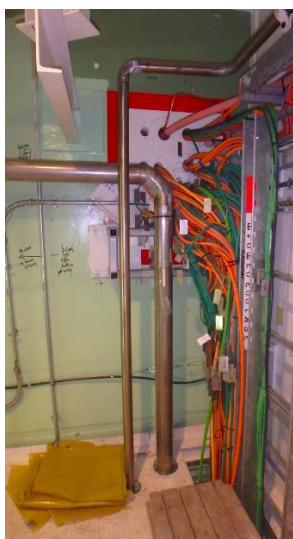
Situation has not improved: see Mario Zadra's photo 23.6.2017

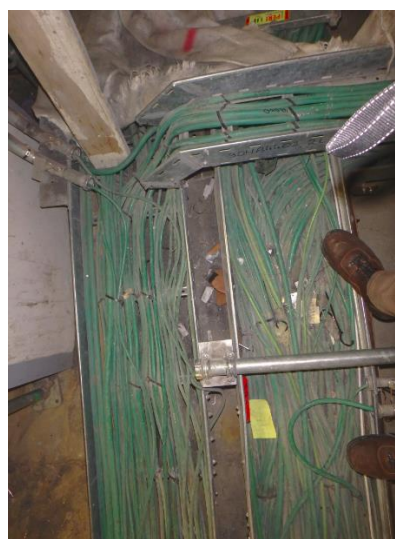
Situation has not improved: see Mario Zadra's photo 8.3.2018

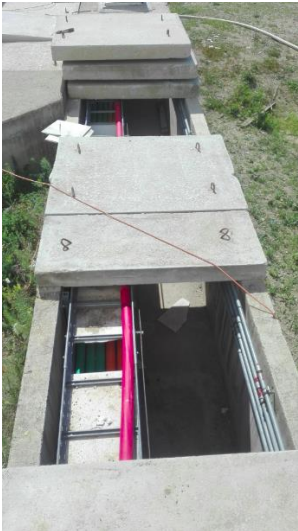
15.6.2017 outside cable canal, open for month, dirt entering

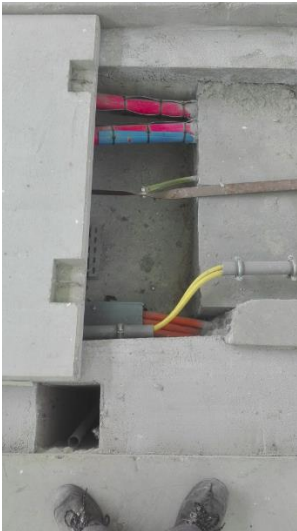
15.6.2017, exposed to weather, dirt and water

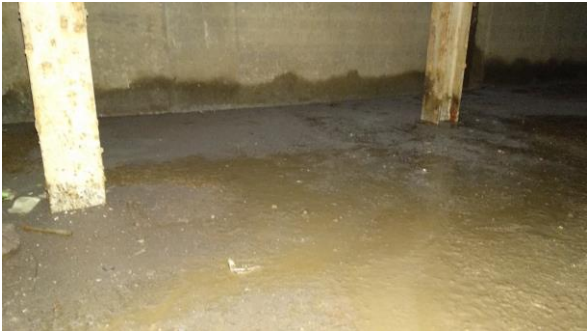
12.1.2018 Room 568 / 1-02, water in basement of canal

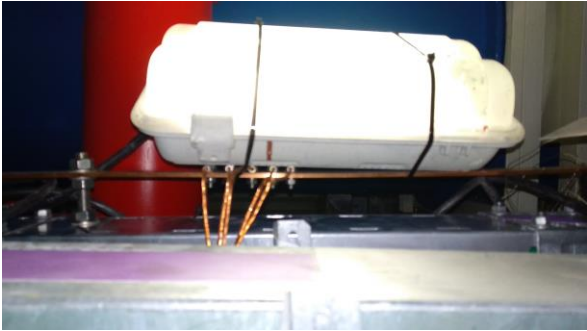
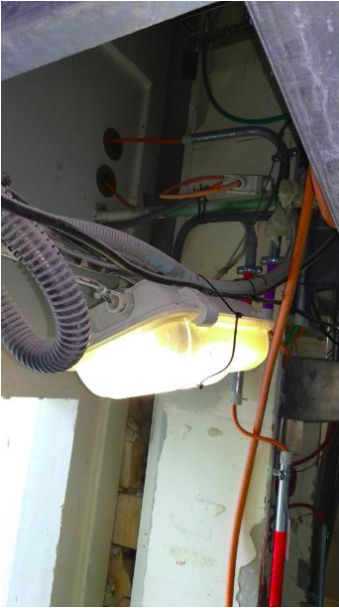
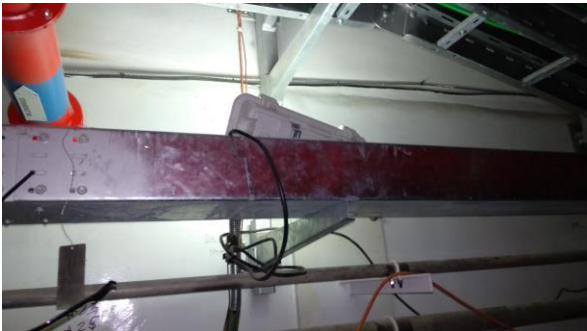
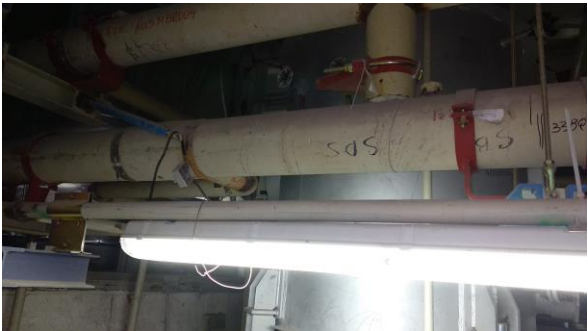
Examples of electric lights installed using cable ties, at the same time fixed dangerously to grounding or control cables

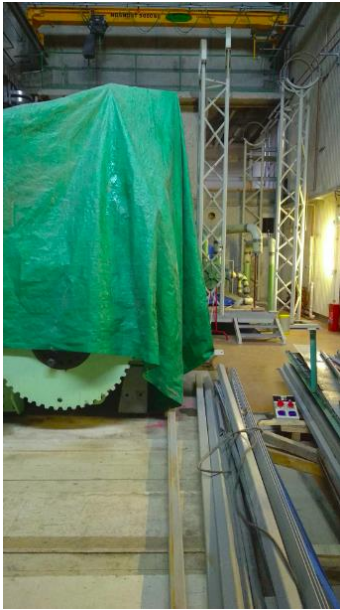
15.5.2018 Emergency Diesel Generator cover wet

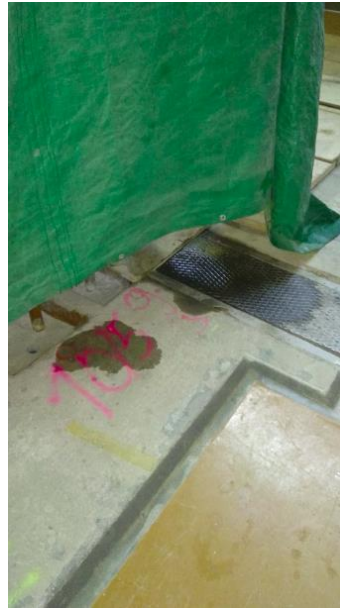
15.5.2018 Emergency Diesel Generator wet patch

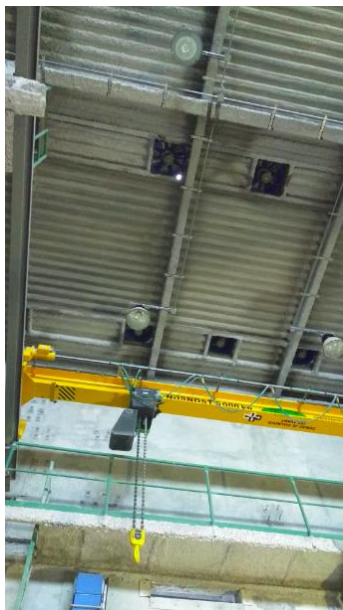
15.5.2018 DG building, hole in roof

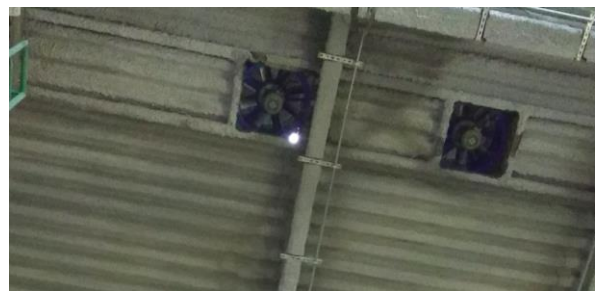
15.5.2018 DG building, hole (enlarged)

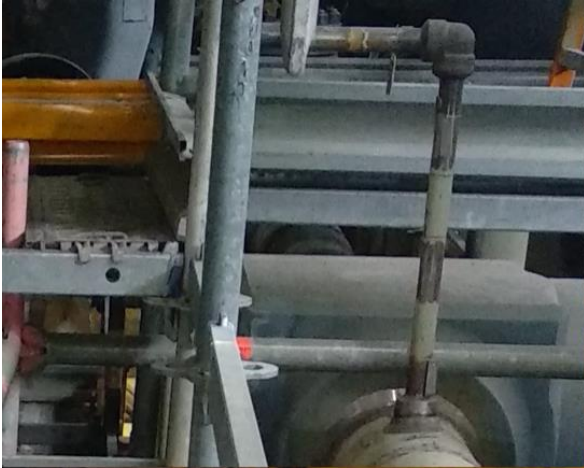
17.5.2018

This example shows numerous welds in a single branch of pipe. Leoncini, a bankrupted subcontractor became notorious for the faking of welds certifications and welder qualifications on-site. The Leoncini problem was apparently recovered through a statistical approach, but this method is unacceptable for safety systems.

There are thousand of repeated welds in Mochovce 3, also in the main lines. This is not acceptable.

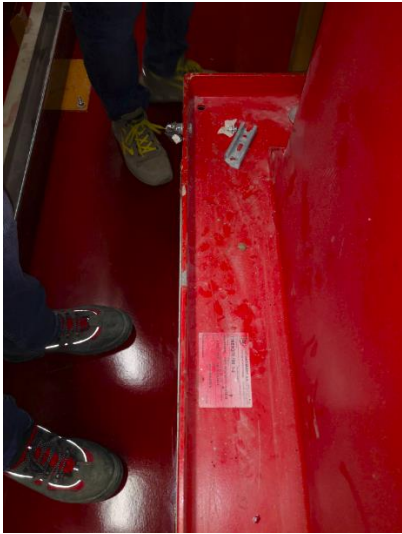
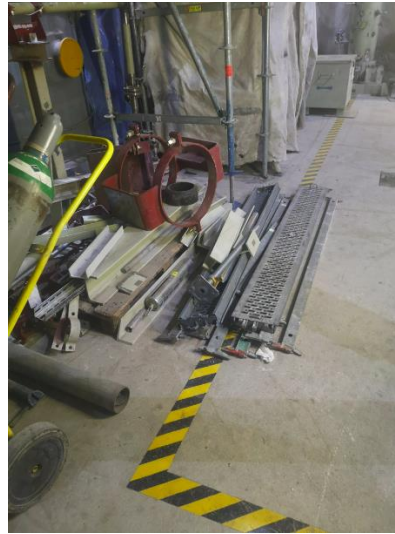
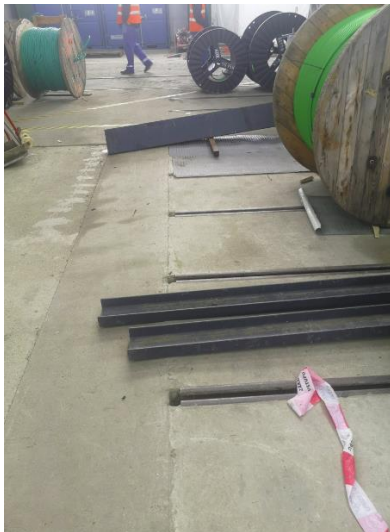
Excessive dirt on site, endangering safety-relevant equipment

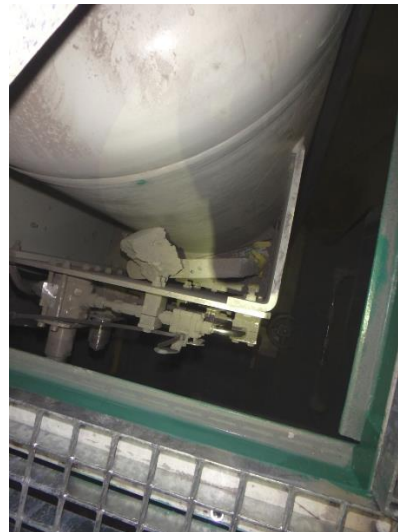
Situation has not improved: see Mario Zadra's photo 18.1.2018

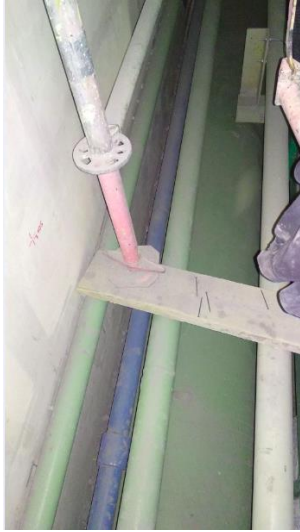
6.2.2018 Scaffolding bearing on piping
